CALSPAN ON-SITE AMBULANCE CRASH INVESTIGATION

SCI CASE NO.: CA11027

VEHICLE: 2009 CHEVROLET G4500 CHASSIS / AEV TYPE III AMBULANCE

CRASH DATE: OCTOBER 2011

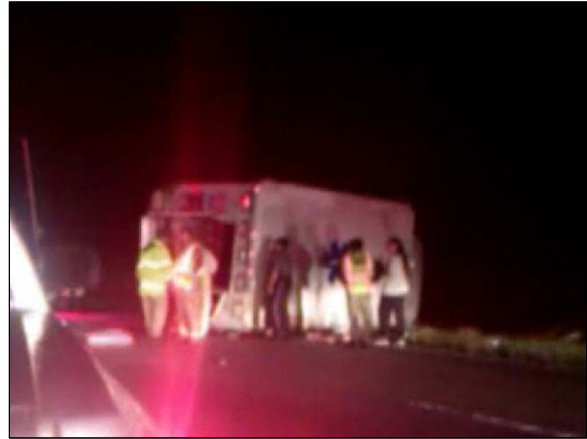
Figure 1: Involved ambulance at final rest (*image from a local news source*).

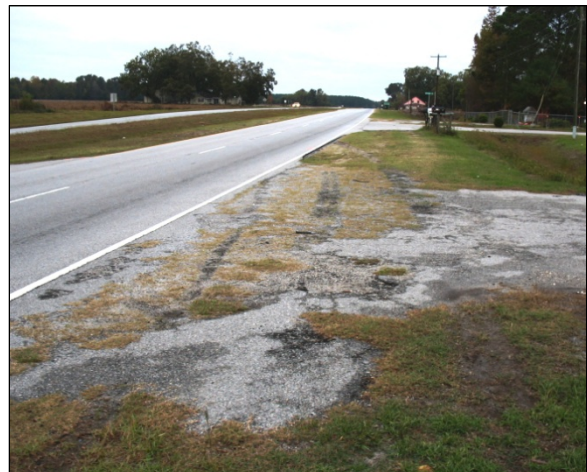
The vehicle maintained a westbound trajectory as it continued its CCW yaw. Due to the sharper curvature of the yaw with respect to the angle of curvature of the roadway, the left front tire reentered the roadway. The point of reentry for the left front tire was located at a distance 62 m (203.5 ft) west of its point of initial departure. Subsequently, the right rear tires reentered the roadway as the vehicle approached 90 degrees of total rotation. The point of reentry for the right rear tires was 120 m (394 ft) west of their initial roadside departure location. The vehicle traversed southwest across both travel lanes as it surpassed 90 degrees of rotation. Tire marks through the roadside swale area and on the asphalt roadway surface evidenced the vehicle's travel path (**Figure 3**).

Figure 3: West-facing view of yawing tire marks through roadside swale.

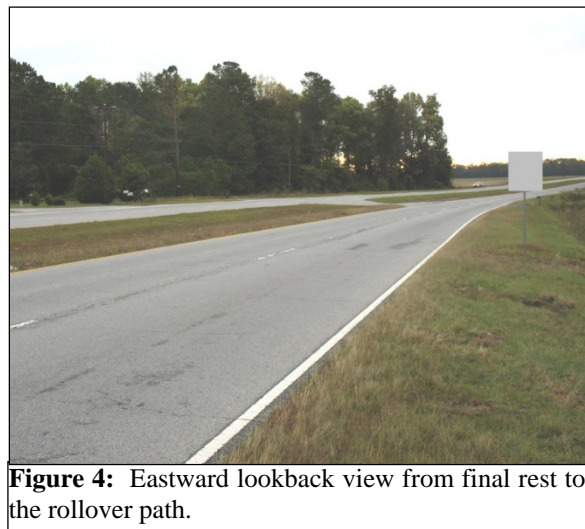
The ambulance's uninterrupted rollover sequence was completed with a minimum of five -quarter turns. During the duration of the rollover sequence, medical supplies, equipment bags, and cabinetry became dislodged from their secured and/or unsecured positions and were subsequently displaced throughout the interior of the patient compartment module. The ambulance came to final rest on its right side, facing south, with the cab straddling the south edge of the eastbound portion of the roadway and the patient compartment module blocking the eastbound portion's right lane. **Figure 4** depicts a lookback view from final rest of the ambulance's rollover path.

Figure 4: Eastward lookback view from final rest to the rollover path.

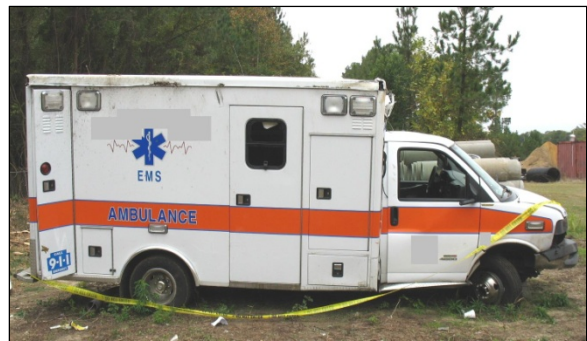
Damage to the exterior of the ambulance from the rollover crash was present on all planes of the vehicle. Overlapping damage patterns on the right side confirmed that a minimum of five - quarter turns. Direct contact on the right side began at the front bumper corner and extended the full 696 cm (274 in) length to the rear bumper corner (**Figure 9**). Damage consisted of body deformation and surface abrasions, and the structural integrity of the patient compartment module was compromised. The right wheelbase was shortened by 9 cm (3.4 in), and the outer tie rod was separated at its linkage. The right front mirror had been fractured from its stalk and was not with the vehicle.

Figure 9: Event 1 damage on the right plane of the AEV patient compartment module.

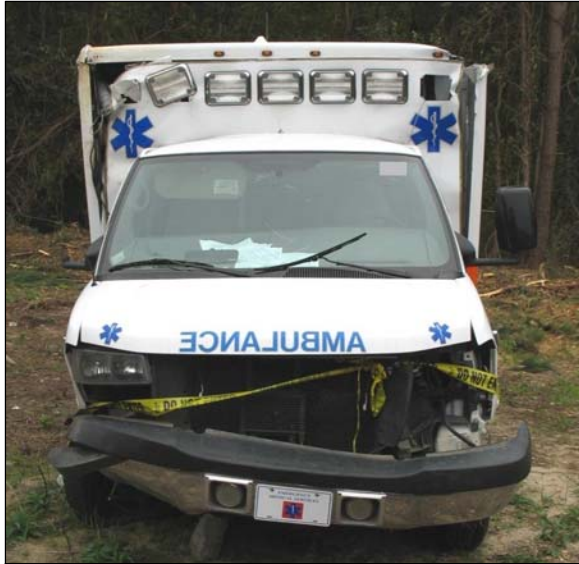
Separation of the frame at the front and rear corners of the right plane during the rollover ultimately resulted in the compromised integrity of the patient compartment module as the frame subsequently separated at other locations during the duration of the rollover sequence. This included separation of the corner frame rail of the left wall from the front plane at the left front corner of the module, as well as the separation of the roof structure along the entire left roof side rail. As a result of this frame separation, the overall structure of the module was angled to the right. This displacement resulted in integrity loss at both forward corners of the patient compartment module (**Figure 10**).

Figure 10: Integrity loss to the patient compartment module as a result of structural compromise.

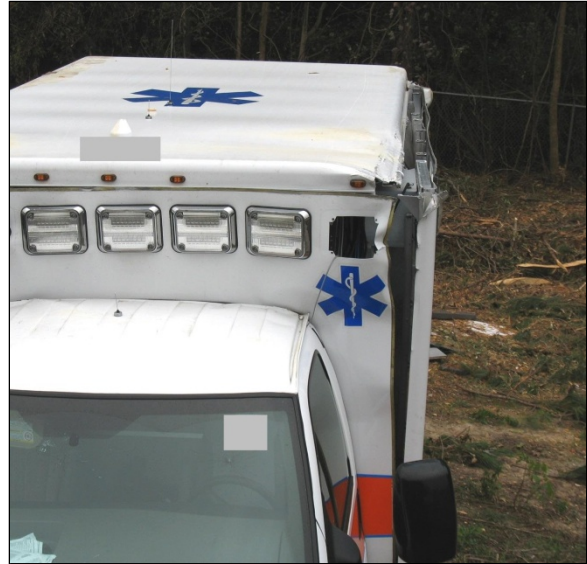
Figure 11: Separation of the roof structure and left roof side rail of the module's frame.

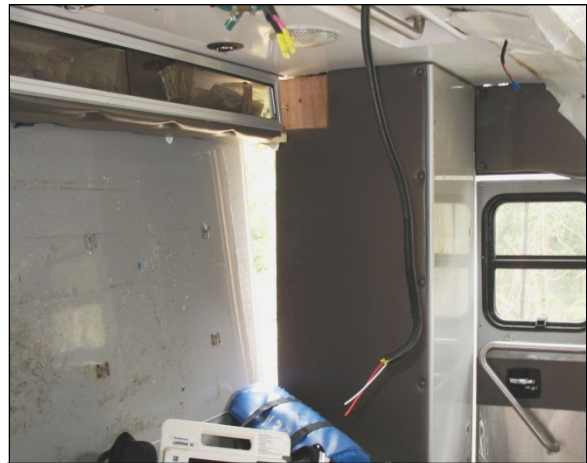
Cabinetry separation occurred at the rear aspect of both the left and right interior walls. On the right wall, aft of the bench seat, structural displacement resulted in the separation of the overhead cabinet as the right wall was displaced 15 cm (5.9 in) right laterally. This included the separation of the wall from the frame of the right rear exterior compartment, resulting in integrity loss between the interior of the patient compartment module and the interior of the right rear exterior storage compartment (**Figure 12**).

Figure 12: Wall and cabinetry separation at the right rear aspect of the patient compartment interior.

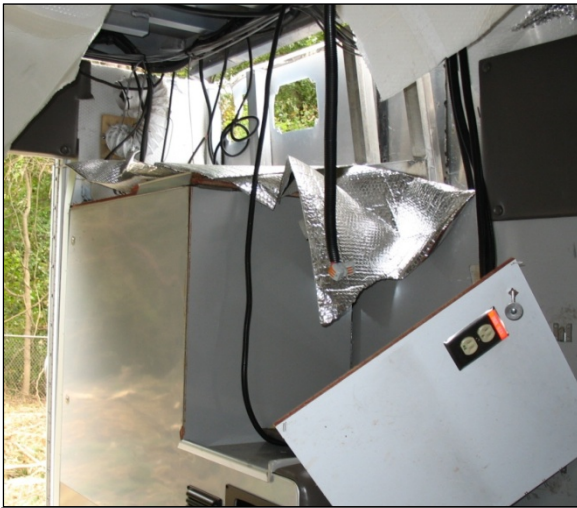
At the rear aspect of the left wall, all three upper cabinets were completely separated from their original mounting locations. The area of cabinetry separation measured 138 cm (54.3 in) long, 52 cm (20.5 in) deep, and 50 cm (19.7 in) tall.

During the crash sequence, these cabinets became dislodged by a combination of the forces associated with the rollover and the separation of the frame structure at the left roof side rail. Subsequently, the separated cabinets moved right laterally and contacted the occupants and right wall. At rest, these cabinets and their components were located scattered throughout the patient compartment and laying on top of the occupants by the Field Supervisor and off-duty medical doctor. They were removed during post-crash emergency operations activities, and were not with the vehicle at the time of inspection. **Figure 13** depicts the upper rear aspect of the left wall at the time of SCI inspection, while a similar view of an exemplar patient compartment in **Figure 14** serves for comparison purposes.

Figure 13: Cabinetry separation at the left upper rear aspect of the patient compartment interior.

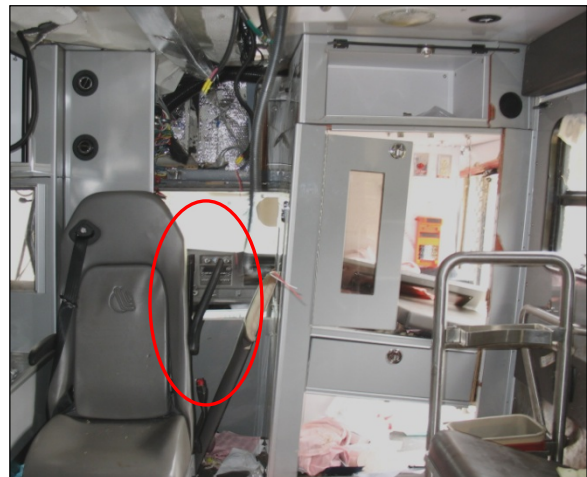
Further cabinetry separation was present at the forward aspect of the patient compartment at the bulkhead. As a result of the aforementioned structure separation, the forward wall separating the interior of the cab from the interior of the patient compartment was completely displaced. This enabled the exposure of the electrical systems enclosed within the cabinetry behind the driver's seating position, as well as the displacement of the locking controlled substance medication cabinet above the pass-through. The stack of cabinetry at the front right aspect of the patient compartment module's interior was also deformed and displaced by the aforementioned structural displacement (**Figure 15**).

Figure 15: Cabinetry deformation at the front right aspect of the patient compartment (*note deformed Captain's Chair armrest and deformed handrail*).

Damage from occupant contact within the patient compartment's interior was identified on the Captain's Chair and the tubular handrail forward of the bench seat. On the Captain's Chair, the left armrest (with respect to the seat's orientation) was deformed laterally toward the right wall of the patient compartment as a result of occupant loading. This lateral deformation measured a maximum of 11 cm (4.3 in) at the end of the armrest. The sharp objects container holder within the handrail forward of the bench seat was also deformed, with a maximum longitudinal deformation extent of 2.5 cm (1 in). The corresponding polymer sharps container was disintegrated.

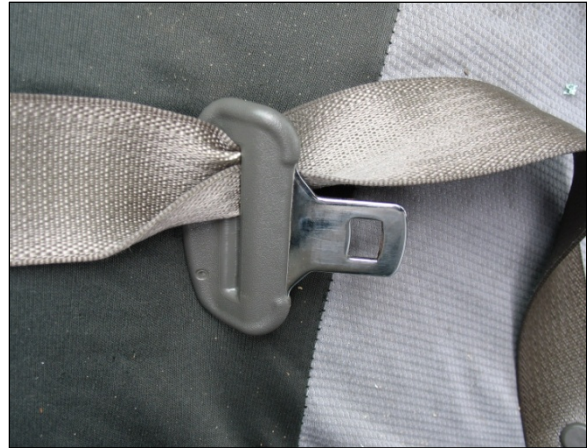
Figure 16: Driver's safety belt webbing gathered within the latch plate.

Both D-ring anchors were adjusted to their full-down positions. The webbing of the driver's safety belt was gathered in the latch plate at a distance 92 cm (36.2 in) from the lower anchor (**Figure 16**). There was also a sharp abrasion on the webbing from the D-ring at a distance 195 cm (76.8 in) from the lower anchor. This evidence confirmed belt usage by the driver at the time of the crash.

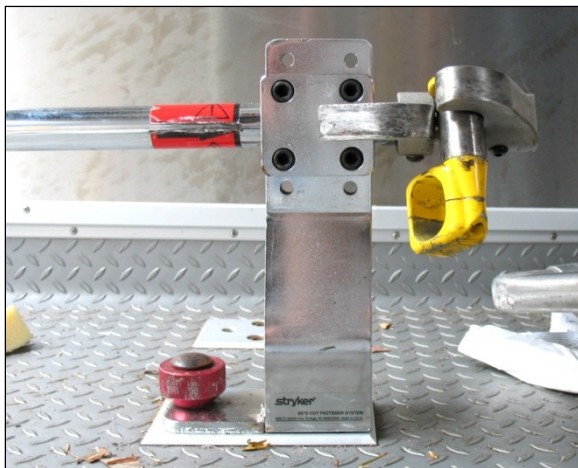
During the rollover sequence, centrifugal and non-horizontal forces associated with the crash induced vertical movement to the stretcher (with respect to the patient compartment module's floor). Due to the location of the locking-clamp mechanism on the left aspect of the stretcher, the mass of the stretcher and aforementioned crash forces induced a positive moment of inertia about the longitudinal axis of the locking clamp. The vertical orientation of the clamp translated an equivalent perpendicular normal force through the anchor pin to the stretcher's frame to restrict the lateral movement of the stretcher.

As the rollover sequenced progressed, the magnitude of the inertial forces increased until the tensile-load strength of the tubular aluminum frame was exceeded. At that time, a 16 cm (6.3 in) section of the tubular aluminum surrounding the anchor pin yielded from the stretcher's frame. Subsequently, the stretcher's movement became unrestricted. **Figure 18** depicts the locking-clamp mechanism with the stretcher's anchor pin still engaged within the clamp at the time of the SCI inspection. **Figure 19** depicts an exemplar locking-clamp mechanism with a similar stretcher secured for comparison purposes.

Figure 18: Locking-clamp mechanism of the Stryker Cot Fastener System at the time of the SCI inspection (*note that the anchor pin is still engaged within the clamp*).

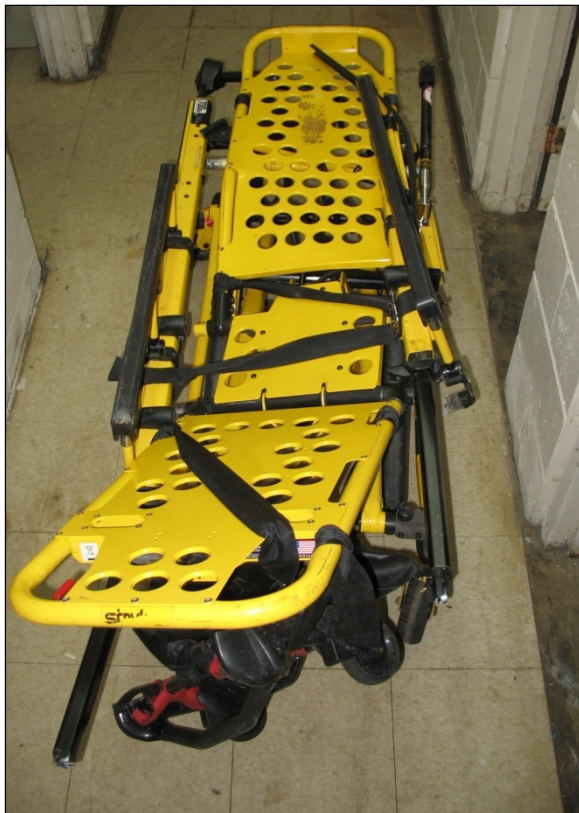
The Stryker Stretcher sustained severe damage as a result of the crash. Numerous frame rail members were yielded in varying locations and several joint welds had fractured. The forward support frame cradled by the antler bracket was separated at its structural hinge joints. The tubular aluminum of the mattress box frame was fractured in multiple locations, and the mattress support panels were deformed and buckled. Two of the four hinge mounts attaching the mattress box frame to the lower X-frame were also separated. The anchor pin and the 16 cm (6.3 in) section were missing from the lower left frame rail. **Figures 20** and **21** provide overall views of the Stryker stretcher at the time of the SCI inspection. It should be noted that the positioning of the manual restraint safety belt straps was performed post crash by emergency response personnel in an attempt to hold the structural components together. No positional adjustments could be made to the stretcher or its components by the SCI Investigator at the time of inspection to test the stretcher's structural integrity due to pending legal implications.

Figure 20: Overall rearward-facing view of the Stryker patient stretcher at the time of the SCI inspection.

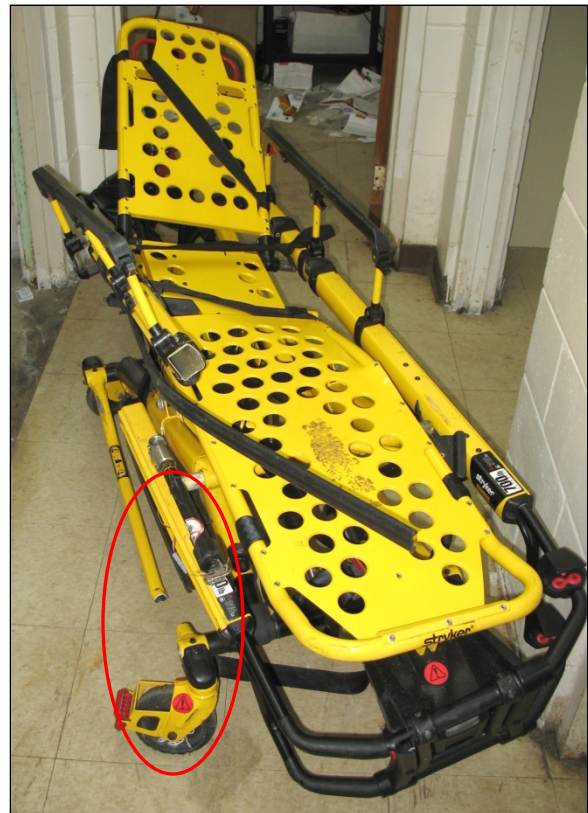
Figure 21: Overall forward-facing view of the Stryker patient stretcher (note missing section of lower frame rail).
